Case Report

Total Rehabilitation of Worn Dentition in a Self-Reported Female Using Pankey-Mann-Schuyler Concept and Methodology- A Case Report

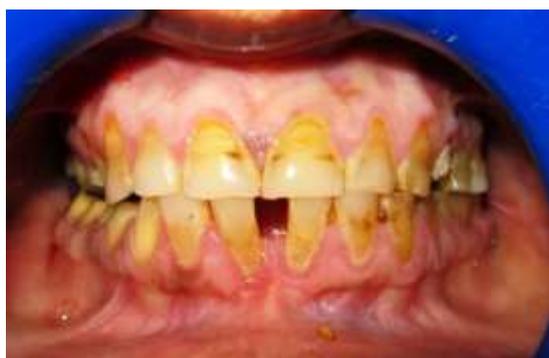
Palpation of masticatory muscles elicited no pain. Intra-oral examination showed generalized attrition and abfractions in anterior teeth (Fig.1). The occlusion was Angle's Class I, with diastemata in the maxillary and mandibular anteriors. Due to severely worn dentition, the anterior teeth had traumatic contacts in maximum intercuspation. Gingival recession was seen in lower anteriors, maxillary canines and maxillary first molars (teeth # 3,14). The discrepancy between vertical measurement at rest and at occlusion was 3mm. She was diagnosed as a case of collapsed vertical dimension due to severely worn dentition and associated clinical changes like non-carious cervical Lesions (abrasion, abfractions), gingival clefts and recession in the maxillary and mandibular anteriors, generalized occlusal wear (attrition); attributed to ensuing occlusal loads from bruxing. Full mouth rehabilitation was planned for her after completion of endodontic treatment of all teeth (Fig. 2) as the available restorative space was inadequate. The steps towards rehabilitation were in the following sequence:

Fig-1; Pre treatment intra oral view

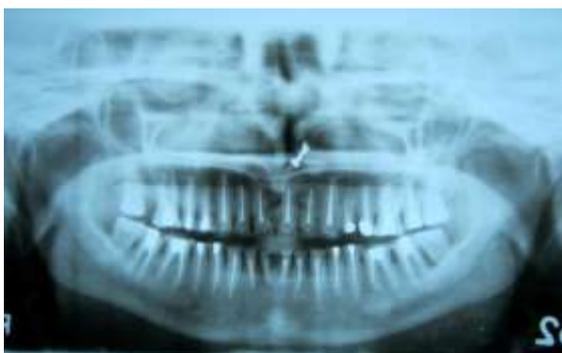
Fig-2: Orthopantomogram (OPG) after Endodontic treatment

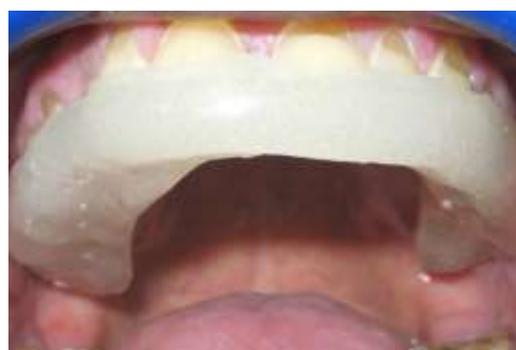
Fig-3: Occlusal splint on maxillary teeth

using bite registration elastomer (Futar D Fast, Patterson Dental Supply, Minnesota, United States). Mandibular cast was mounted using interocclusal records. An acrylic stabilization splint was fabricated on a duplicated maxillary cast to the proposed vertical dimension and the patient was asked to wear it for 3 weeks (Fig. 3). Meanwhile, a diagnostic wax-up (Fig. 4) was made to serve as a blue-print for the provisional restorations. The provisionals were fabricated from putty indices (Aquasil, Dentsply, Gurgaon, India) of the diagnostic wax-up. The posterior occlusal plane was established with an indigenous Broadrick flag stabilized in acrylic resin [5] (DPI RR cold cure, Mumbai, India) (Fig.5). The provisional restorations (Protemp Plus, 3M ESPE, United States) were cemented with Zinc Oxide Non-Eugenol temporary cement (RelyX Temp NE, 3M ESPE, United States) after minimal preparation of teeth. The patient was left to function with provisionals for 6 weeks.

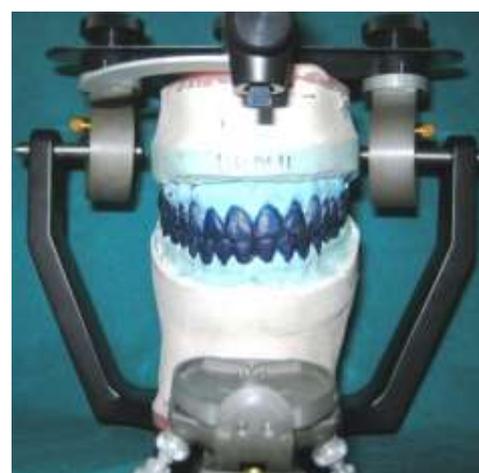
Fig-4: Diagnostic wax-up

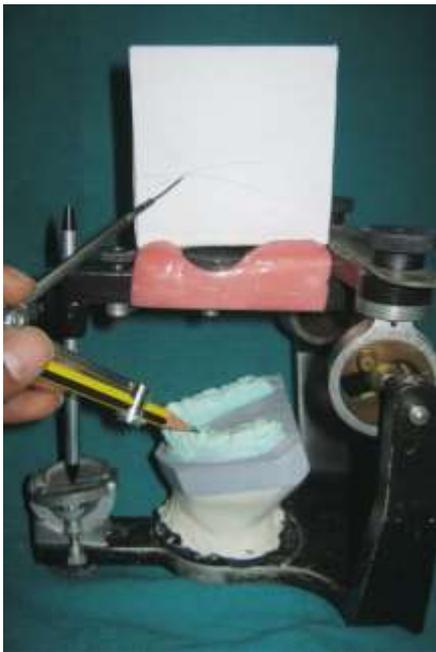
Fig-5: Occlusal plane analyzed using Broadrick Flag

In this case the Pankey-Mann- Schuyler philosophy modified by Dawson was adopted. The anteriors were restored first [12]. The anterior occlusal plane was established using esthetics and phonetics as guides [10]. The posterior occlusal plane was analyzed during the diagnostic work-up using a Broadrick flag [13,14]. The wax-up was modified accordingly and provisional crowns were fabricated. The treatment objectives - esthetics, function and occlusal stability are all incorporated into provisional restorations replicated from a diagnostic wax-up. The goal of the treatment sequence is to transfer the proposed esthetic and functional occlusal changes from the diagnostic wax-up via the provisional restoration to the patient's mouth, which is the key to a successful definitive restoration [15-19]. While fabricating the provisional restorations,

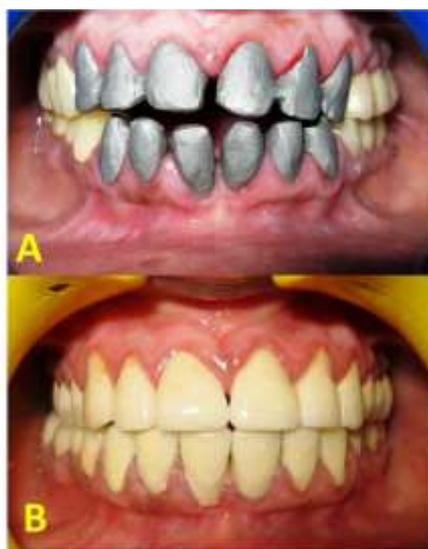
Fig-6: A) Anterior metal-coping trial with posterior provisional restorations in place and B) Anterior definitive crowns (Anterior guidance established first)

After confirmation of painless functioning, the anterior provisionals were removed and final tooth preparations were done. Gingival retraction (Ultrapak, Ultradent Products Inc., South Jordan, Utah and United States) and impressions were followed by bite registration while the posterior provisionals remained in place to maintain the bite. Metal ceramic crowns were fabricated (Fig 6A and 6B) for the maxillary and mandibular anteriors and cemented with provisional cement (RelyX Temp NE, 3M ESPE, United States).

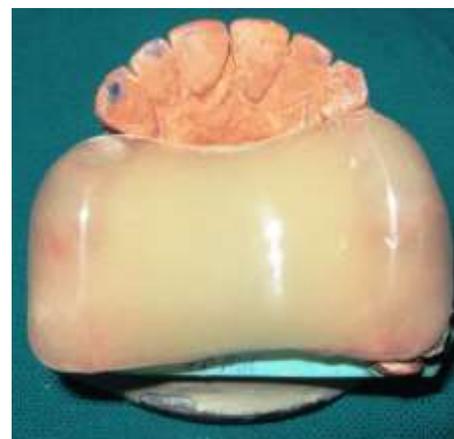
Fig-7: Functional recording plate to capture functionally generated path

Mandibular posterior temporaries were removed and teeth were prepared for final crowns. The mandibular posterior PFM crowns were cemented provisionally (Rely X Temp NE, 3M ESPE). A Functional recording tray was fabricated in self cure clear acrylic resin over Maxillary posterior prepared dies. The tray loaded with Aluwax (Aluwax, Michigan, United States) inserted in the mouth and patient is asked to perform functional mandibular movements (Fig 7). A functionally generated impression of mandibular posterior teeth is recorded in Aluwax which was poured to get functional core (functionally generated pathway). This functional core is sectioned into right and left posterior parts which were later articulated on verticulator with its corresponding and opposing master cast dies (verticulator allows only up and down movement) (Fig 8A and B). The ceramic build-up on maxillary posterior teeth completed on the verticulator using functional core as a guide. Maxillary posteriors contoured with such technique would be most compatible to the various functional movements of mandible.

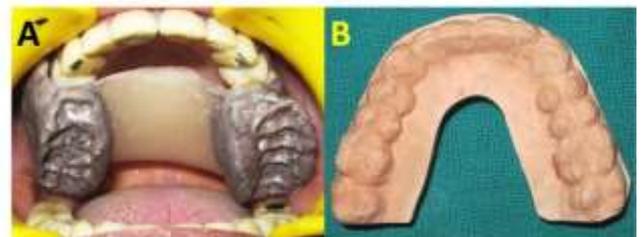
Fig-8: Functionally generated impression of mandibular posterior teeth in Aluwax (A) and Obtained functional core (B)

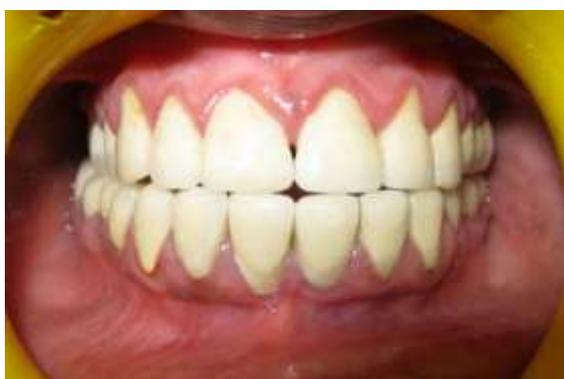
Fig-9: Post cementation view of protrusive-light contacts on anteriors and posterior disocclusion

The definitive crowns were cemented (Fig 9) with luting Glass Ionomer Cement (Type I GIC, GC, Fuji) after a two week follow-up and intra oral occlusal adjustment was done using 12 μ metallic articulating paper (Arti-Fol, Bausch) as it possesses good color transfer (unlike the conventional shim-stock) and high spots can easily be detected, especially on ceramic. The patient was placed on a maintenance recall of 3 months initially for assessment of hygiene and periodontal health.
